# A Novel Approach to Beach Erosion Monitoring in the Caribbean

Implementation of a Video Monitoring System (VMS) in Hellshire, Jamaica

*National Environment and Planning Agency, Jamaica*

*June 2023*

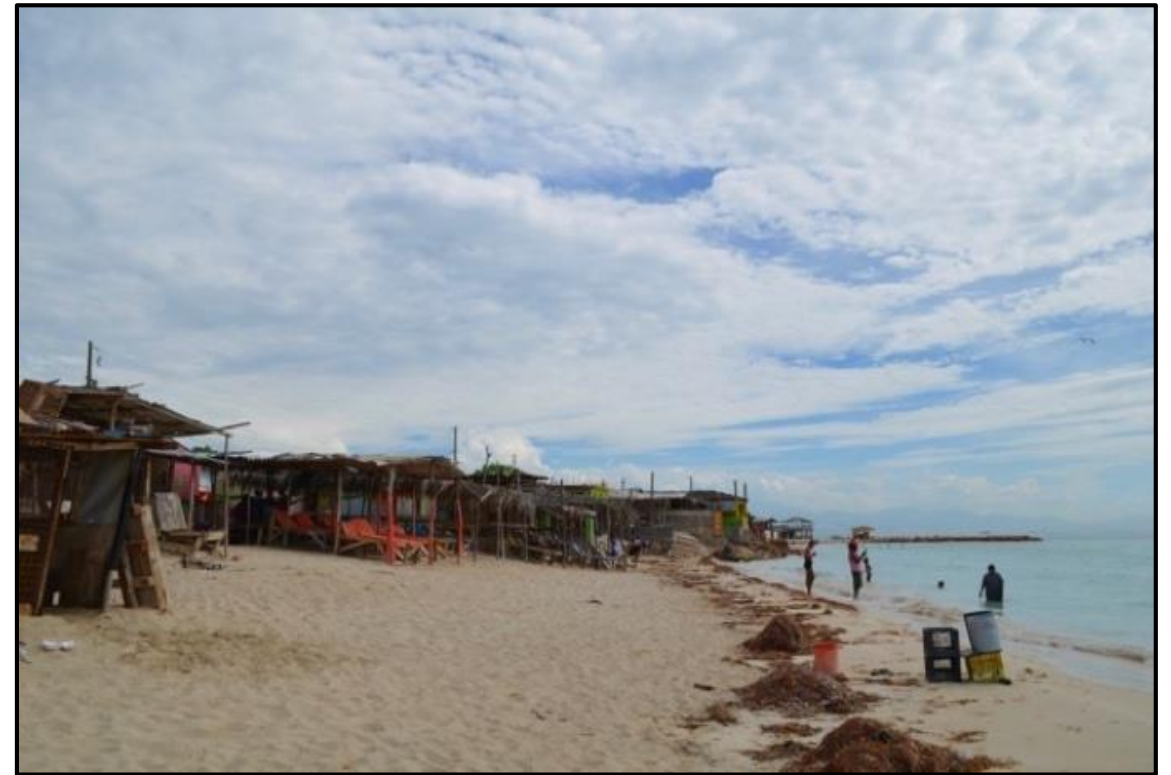
- **Vegetated sand dunes**
- **Beach width approx. 40 meters wider**
- Temporary wood and zinc structures which served as restaurants and housing
- Bays were sheltered by relatively healthy coral reefs and seagrass beds

Section of the most easterly tip of Hellshire beach circa 2010. Source [caribbeancables.com](http://caribbeancables.com)

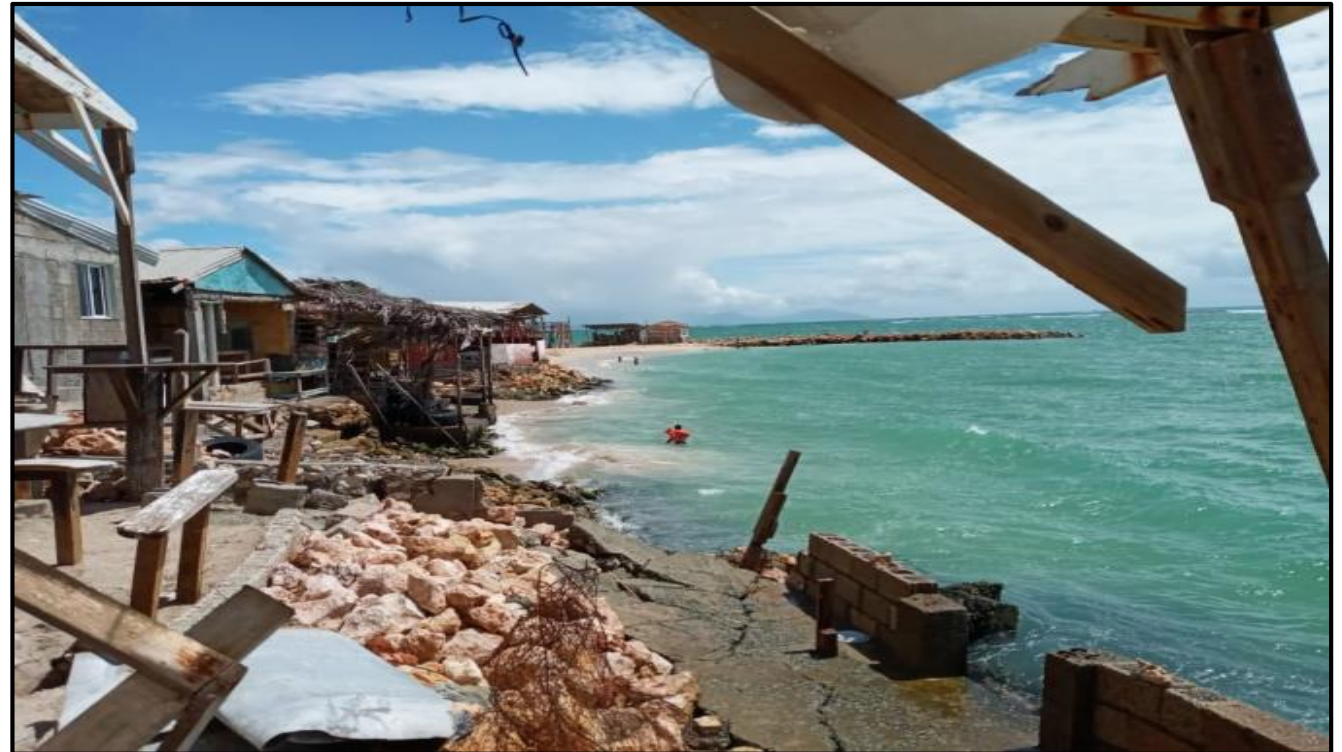
- **Hurricane Ivan (2004) and other storms**
- **Poor water quality**
- Poor reef health
- Hard structures constructed

Remaining sections of a 'sea wall built by business owners. Source Andrew Bellamy 2020.

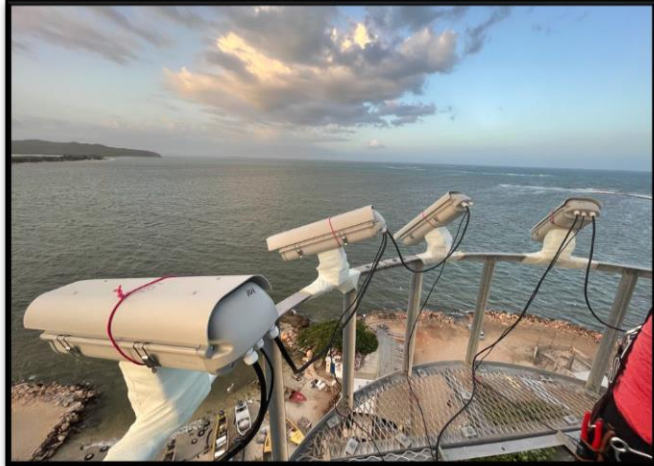
7 cameras

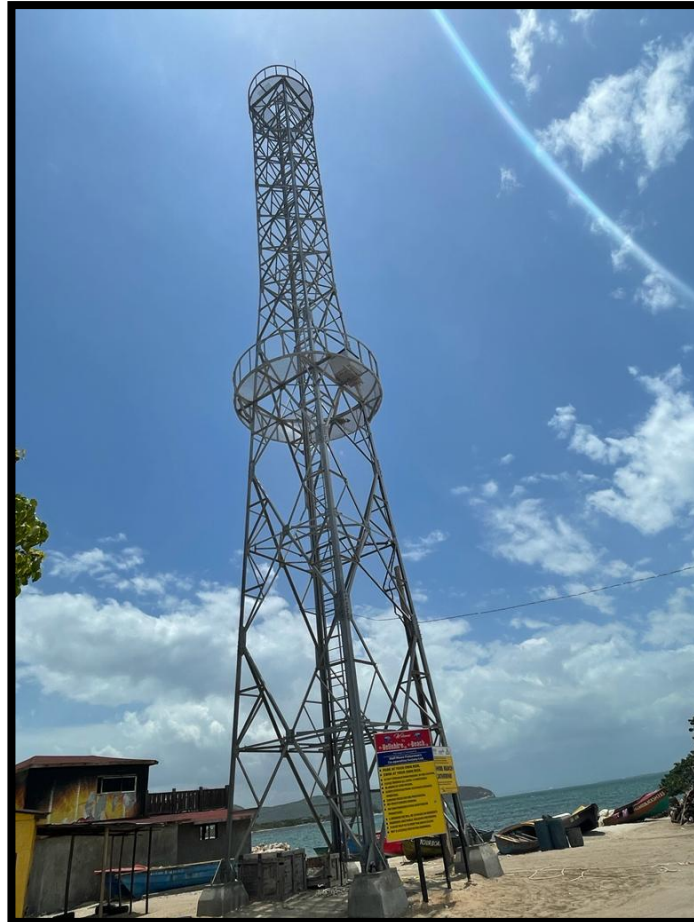
30 meter lattice steel tower

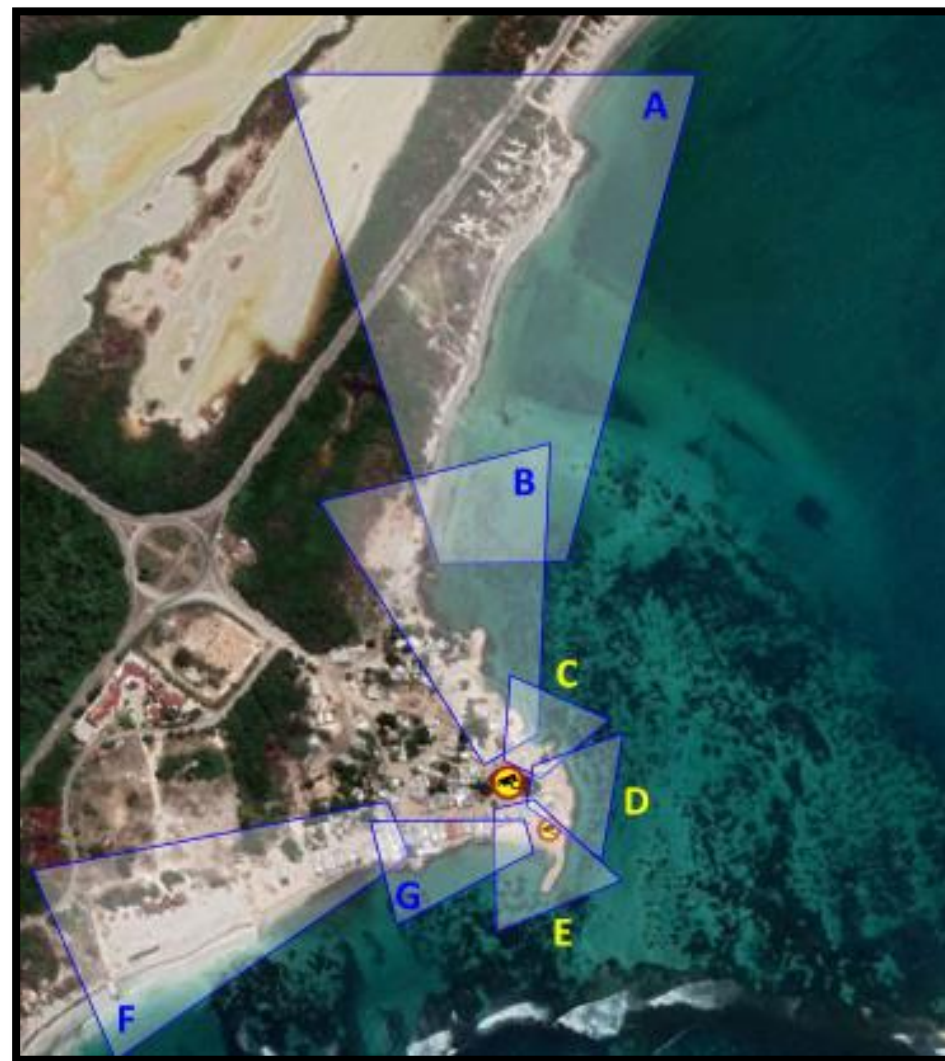
System installation location diagram

- Approximately 200 meters monitored to the North and South.

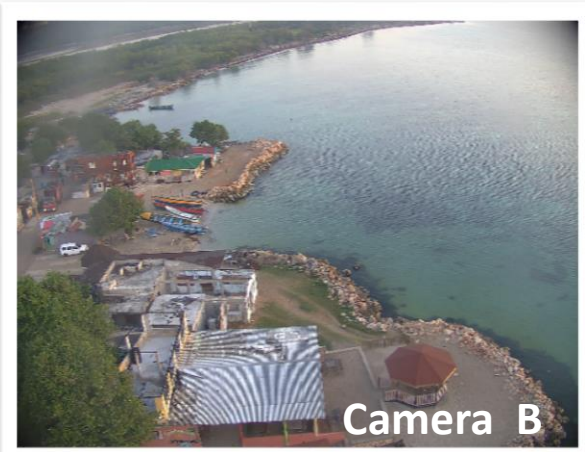
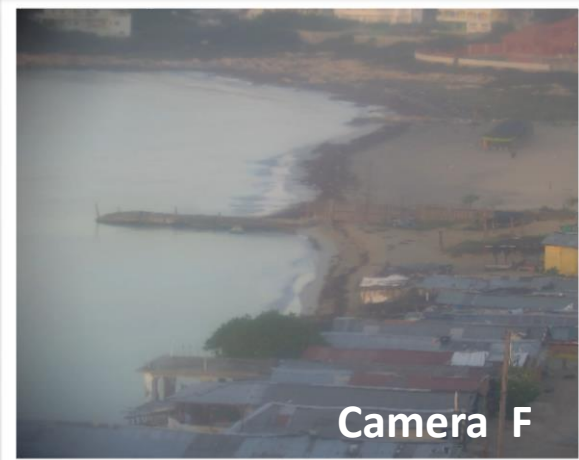
- Images captured: 0710hrs to 1840hrs
- 72 images generated daily; image processor produces 1 average image per day
- Averaged images used to create orthometric mosaic

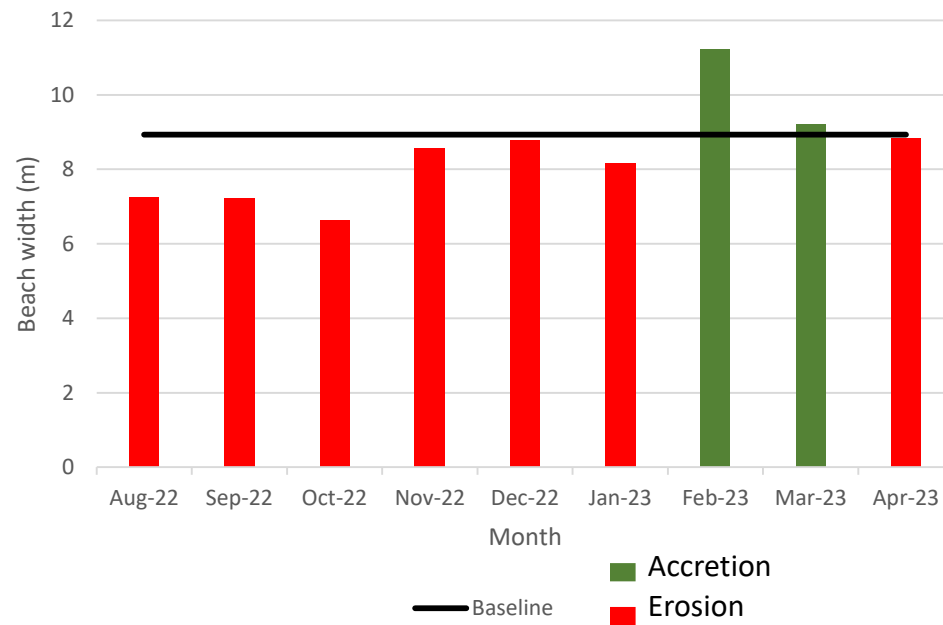
Beach Cell 1 July 2022 vs. April 2023

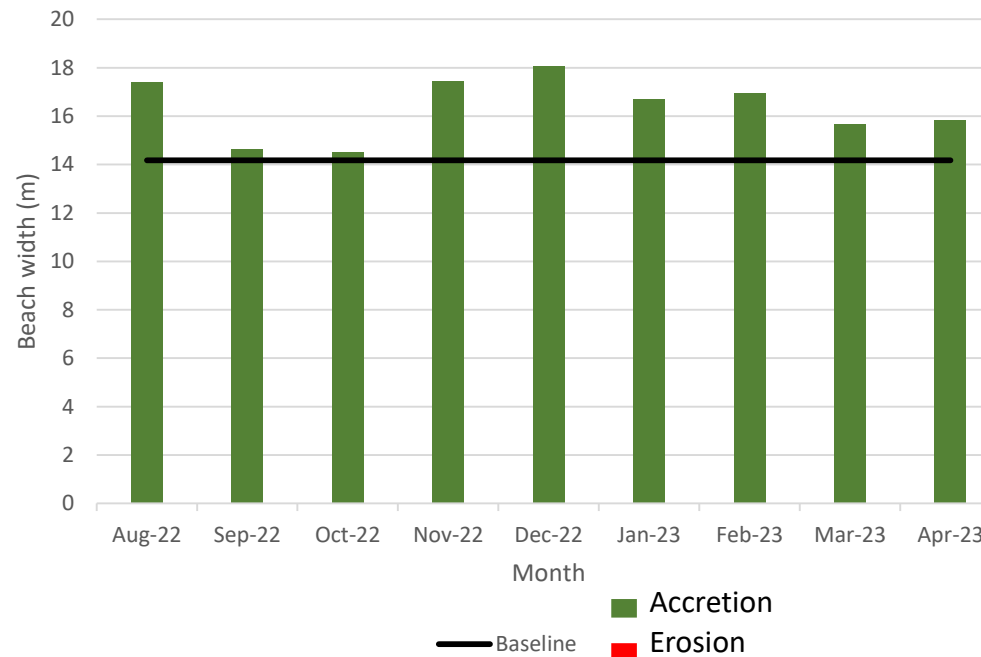
Beach Cell 2 July 2022 vs. April 2023
